Manhole Inspection Summary

Manhole # S33I__025MH

Location Address: **250 howard st**

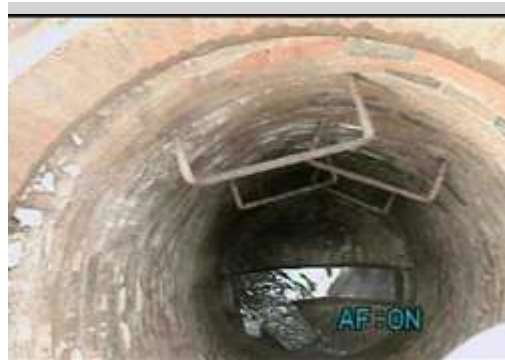
Defect 2

bench debris

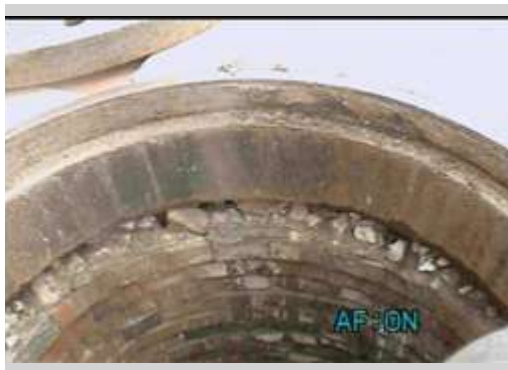
Defect 1

Condition: ☐ Sound ☐ Cracked ☐ Root Intrusion ☒ Loose Brick ☒ Deteriorated

chimney deteriorated offset frame adjustment

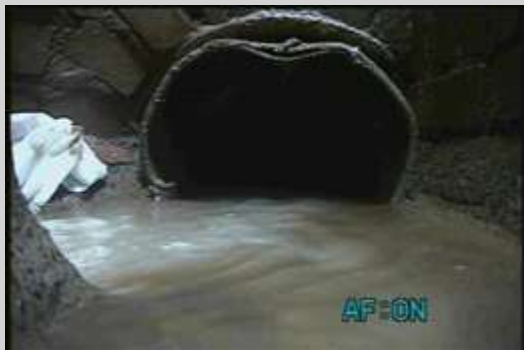
12 O'Clock Outflow

10 in. Circular Gravity Sewer
Pipe Out @ 12 O'Clock

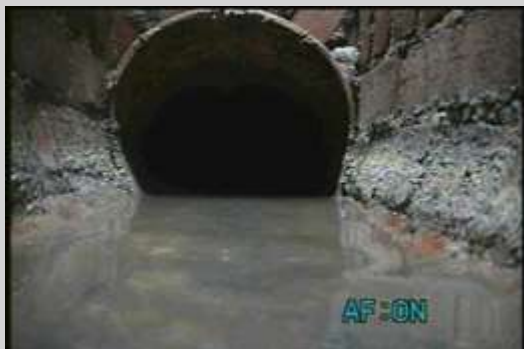
6 O'Clock Inflow

10 in. Circular Gravity Sewer
Pipe In @ 6 O'Clock

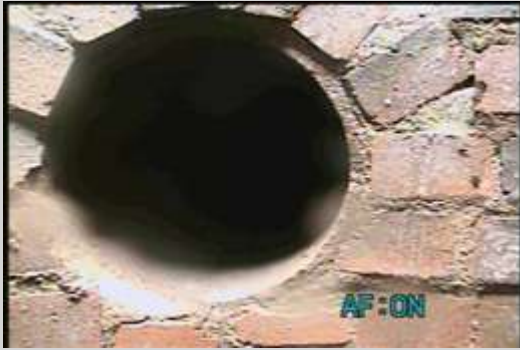
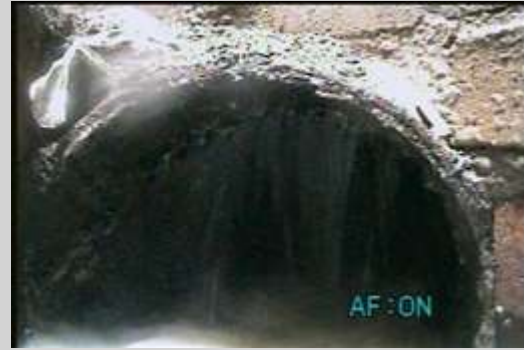
9 O'Clock Inflow

8 in. Circular Gravity Sewer

Pipe In @ 9 O'Clock

Drop In @ 9 O'Clock

Invert Depth: **5.33** (ft.) Flow Characteristics: **Turbulent**

Drop: **Outside Direct**
